**Flood Control Project Maintenance
Levee Inspections**

Maintenance Issue Types Only, Levee Inspection Report By Mile - Fall 2016

Sutter Maintenance Yard Maintenance Area 0016

Waterway	Bank	Unit Miles	Inspection Start/End	Inspector
Unit No. 01 Feather River	Right	4.06	09/08/2016 09/08/2016	Sterling York

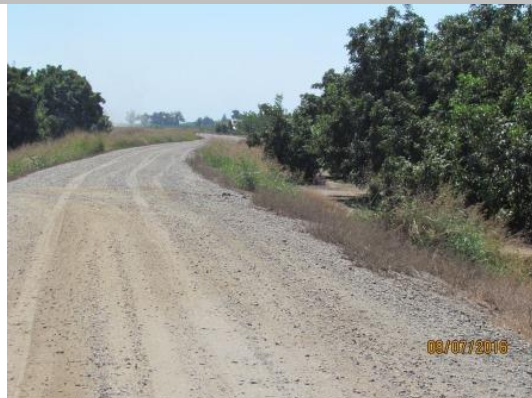
Photo 1 of 1 : FA_2016_MA0016_302_10_20160912_00013.jpg

LM Start	3.19	Rating **	M	Issue No.	10
LM End	3.65	Issue Type +	Ma	Location *	LS
Category	Earthen Levee			GPS Latitude/Longitude	
				Start	End
Item	Vegetation			39.298312 °	39.305053 °
				-121.638327 °	-121.637729 °
DWR ID	DWR_MA0016_01_f_2016_10				
Comment Code					
V1 : Control annual grass and weeds on the levee slopes and easements.					
Inspector Comment					
Annual grasses that need to be maintained.

View looking downstream, landside, of annual grasses that need to be maintained.

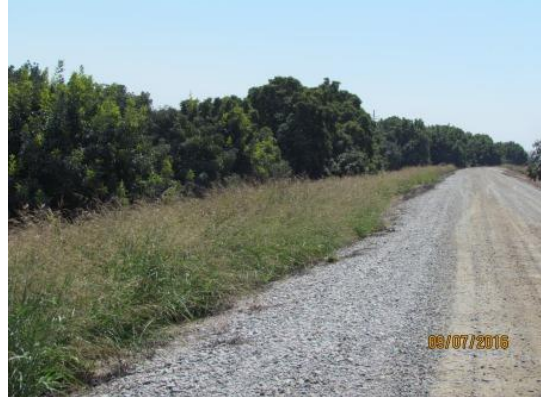
Photo 1 of 1 : FA_2016_MA0016_302_9_20160912_00012.jpg

LM Start	3.19	Rating **	M	Issue No.	9
LM End	3.81	Issue Type +	Ma	Location *	WS
Category	Earthen Levee			GPS Latitude/Longitude	
				Start	End
Item	Vegetation			39.298312°	39.307293°
				-121.638328°	-121.637671°
DWR ID	DWR_MA0016_01_f_2016_9				
Comment Code					
V1 : Control annual grass and weeds on the levee slopes and easements.					
Inspector Comment					
Annual grasses that need to be maintained.

View looking downstream, waterside, of annual grasses that need to be maintained.
